# **EXHIBIT No. 5**

ARCCA, INCORPORATED  
146 N CANAL STREET, SUITE 300  
SEATTLE, WA 98103  
PHONE 877-942-7222 FAX 206-547-0759  
www.arcca.com

Re: *Quinn, Dennis v. Marie Ronkar*  
ARCCA Case No.: 3691-015

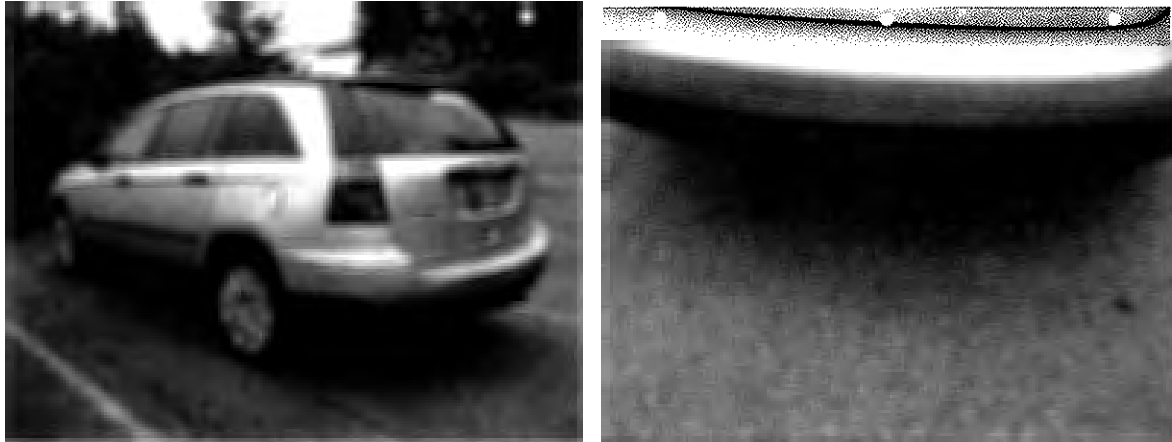
**Figure 1: Reproductions of photographs of the subject 2006 Chrysler Pacifica**

The reviewed photographs of the subject Chrysler Pacifica depicted scuffing/scraping damage to the rear bumper cover (Figure 1). The photographs depicted slight indentation to the upper silver bumper cover, however, there was no significant misalignment or crush. Mr. William Ronkar testified the subject Chrysler damage consisted of "minimal" damage including scuffing to the rear bumper cover. Mr. Quinn testified the subject vehicle damage was to the middle of the back

bumper, including scrapes and markings on the bumper. He further testified that when he had the subject Chrysler repaired he was told the *"bumper assembly that attaches to the frame was cracked."*

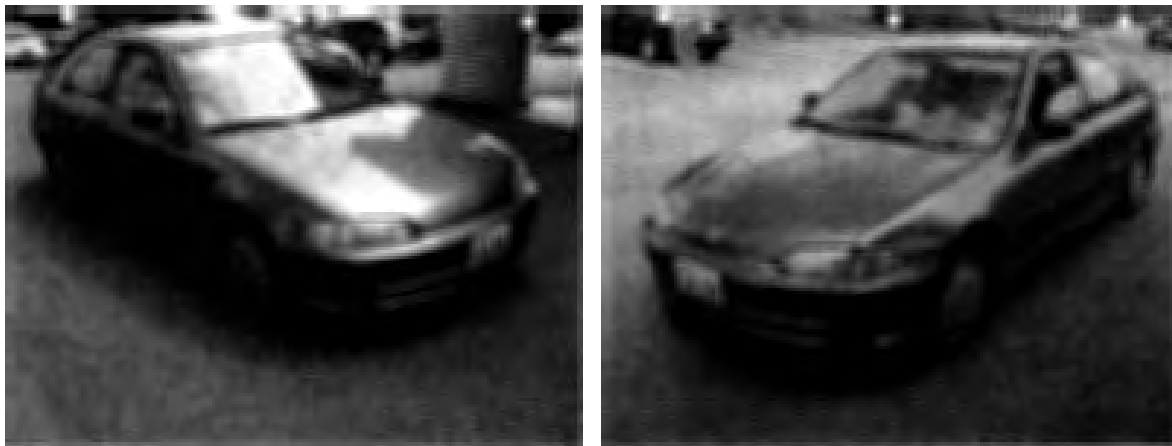
The reviewed photographs of the incident Honda Civic depicted damage skewed toward the left front corner as indicated by the left fender, left front bumper cover and turn signal lamp deformation. Ms. Marie Ronkar testified the incident Honda damage consisted of the headlight being broken. Further, within Ms. Ronkar's deposition it is indicated there was damage to the front bumper cover, left turn signal, hood, left fender, left fender liner and various other parts on the Honda. Mr. Ronkar testified the incident Honda damage was the *"front left headlight was smashed out"*, *"little bit of a buckle to the hood"*, and a *"little bit of a buckle to the left fender"*. Mr. Quinn testified the *"front left bumper and headlight was cracked"* on the incident Honda.

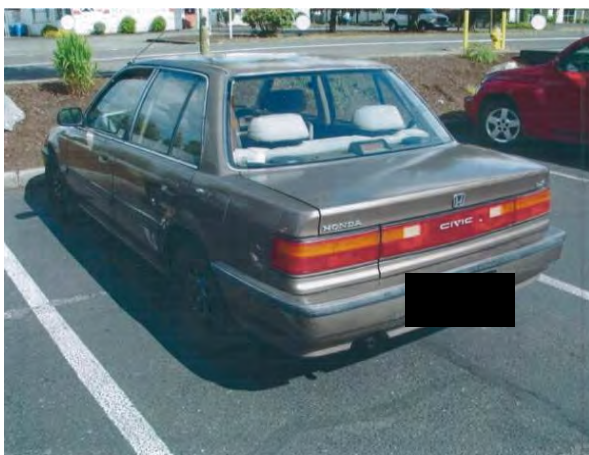
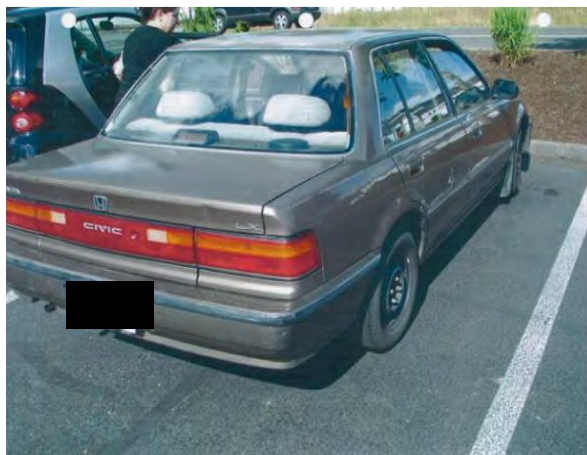
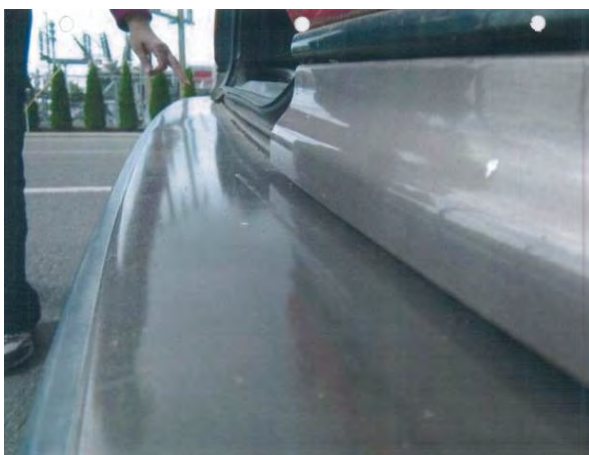
**Figure 1: Reproductions of photographs of the subject 1991 Honda Civic**

Analyses of the photographs and geometric measurements of the subject 1991 Honda Civic revealed the damage due to the subject incident. An energy crush analysis<sup>13</sup> indicates that a single 10 mile-per-hour angled barrier impact to the rear of a Honda Civic would result in significant and visibly noticeable crush across the entirety of the subject Honda's rear structures, with a residual crush of 5.5 inches. This depth of crush would include damage to the trunk lid, rear tail lights, rear body panel, and rear bumper structures. Therefore, the energy crush analysis shows significantly greater deformation would occur in a 10 mile per hour Delta-V (the Delta-V is the change in velocity of the vehicle from its pre-impact, initial velocity, to its post-impact velocity) impact than that of the subject incident.<sup>14</sup> The lack of significant structural crush to the entire rear of the incident Honda Civic indicates that the subject incident is consistent with a collision resulting in a Delta-V significantly below 10 miles per hour for the subject Honda Civic.

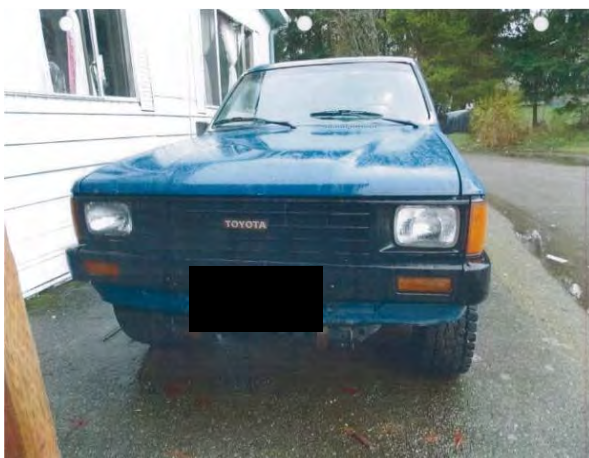
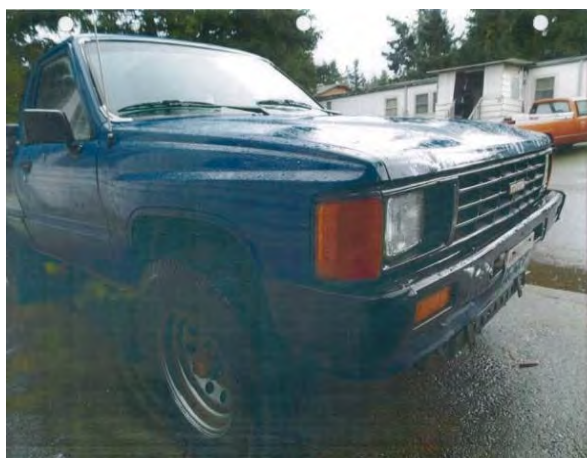
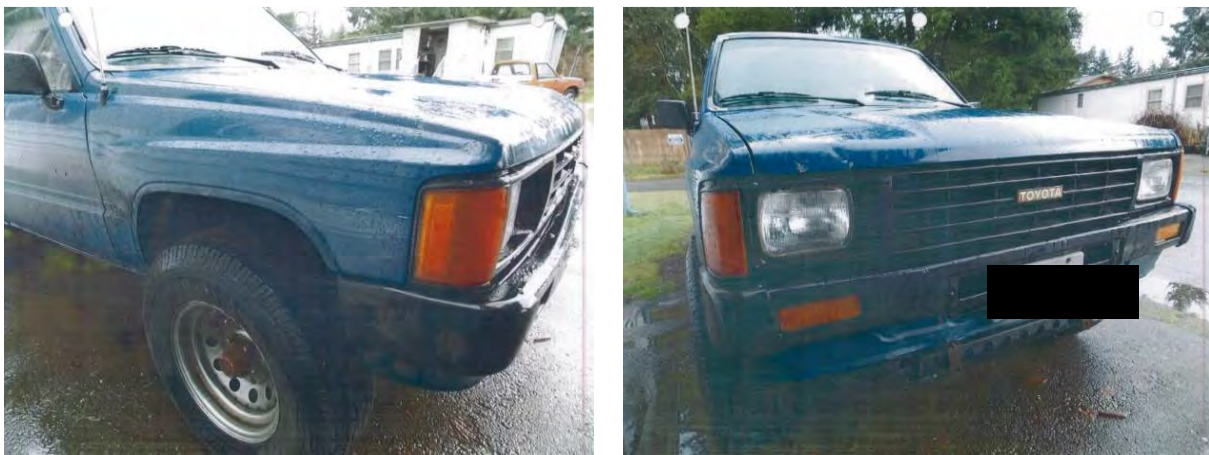
**Figure 2: Reproductions of photographs of the incident 1984-1988 Toyota Pickup**

The reviewed photographs of the incident Toyota depicted damage consisting of a bent front license plate. Specifically, the license plate was bent along its horizontal axis and there was no significant crush to the front bumper structures of the incident Toyota (Figure 2). [REDACTED] testified that she could not recall any damage that she remembered seeing on the incident Toyota.

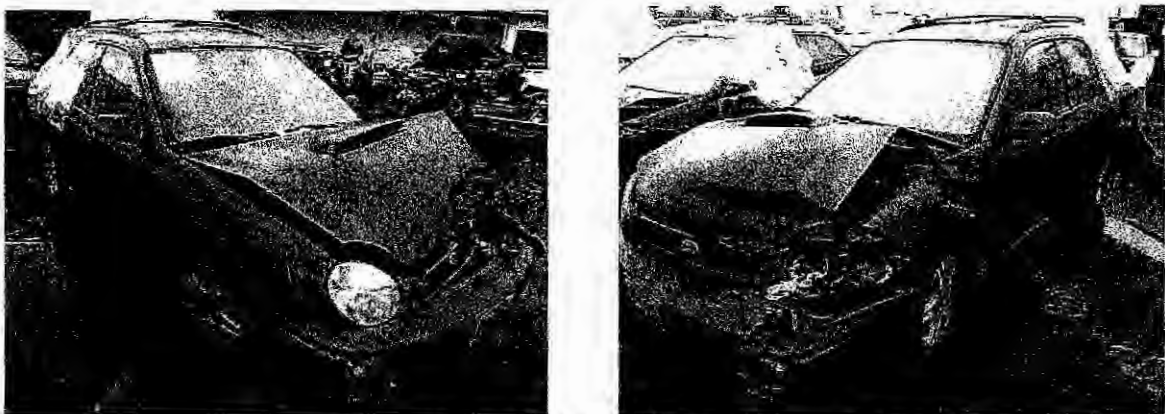
**Figure 2: Reproduction of the incident 2002 Subaru Impreza**

The repair estimate for the incident Subaru indicated there was damage primarily to the left quarter panel, left rear frame rail, left inner quarter panel, left rear quarter panel pan, tailgate assembly, rear bumper assembly, muffler assembly, rear body panel, rear floor pan, left tail lamp assembly, and the left front half body section; which is consistent with the available photographs. Additionally, the Subaru required a 4 wheel alignment and a unibody/frame setup. The photographs depicted considerable crush damage to the rear of the incident Subaru (Figure 2). Further, the photographs depicted crush damage to the left front, primarily above the front bumper structure.

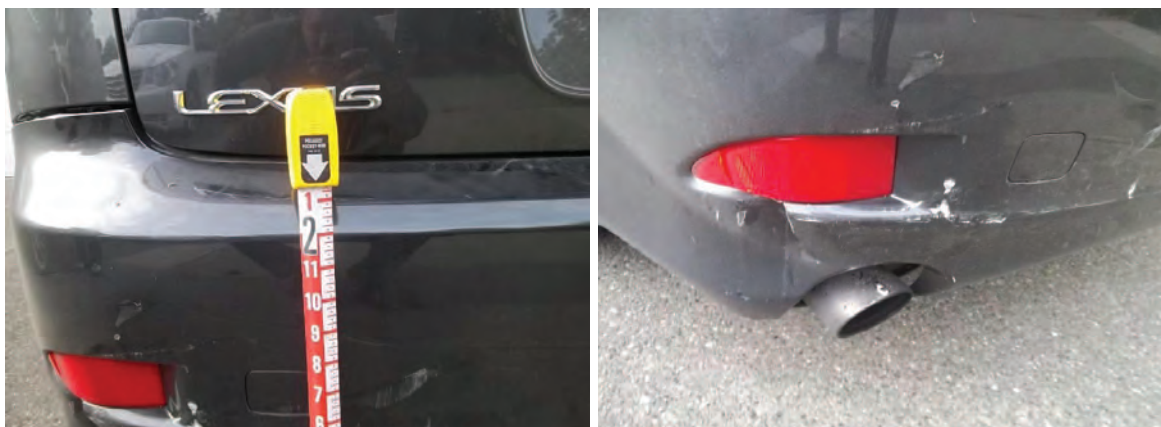
**Figure 1: Photographs of the subject 2009 Lexus IS250**

The reviewed photographs of the subject Lexus IS250 depict damage to the rear bumper cover on the left side (Figure 1).

The Insurance Institute for Highway Safety (IIHS) performs low-speed tests on vehicles to assess the performance of the vehicles' bumpers and the damage incurred. The damage to the subject 2009 Lexus IS250 defined by the photographic reproductions, and confirmed by the repair estimates, was used to perform a damage threshold speed change analysis.<sup>6,7</sup> The IIHS tested a 2007 Lexus IS250<sup>8</sup>, essentially the same vehicle as the 2009 Lexus IS250, in a 5 kilometer-per-hour, or 3.1 mile-per-hour, rear corner impact into a simulated bumper. The test Lexus sustained damage, shown in Figure 2, to the quarter panel, rear body panel, and rear bumper cover. Thus, because the test Lexus in the IIHS rear corner impact test sustained comparable damage, the severity and energy transfer of the IIHS impact is similar compared to the severity of the subject incident and places the subject incident at 5 kilometers -per-hour for the subject Lexus IS250. Review of the vehicle damage, incident data, published literature, scientific analyses and my experience indicates an incident resulting in a Delta-V below 5 kilometers-per-hour for the subject Lexus. Using an acceleration pulse with the shape of a haversine and an impact duration of 150 milliseconds (ms), the peak acceleration associated with a 3.1 mile-per-hour impact is 1.9g.<sup>9,10,11,12</sup> By the laws of physics, the average acceleration experienced by the subject Lexus IS250 in which Ms. Ake was seated was less than 1.9g.

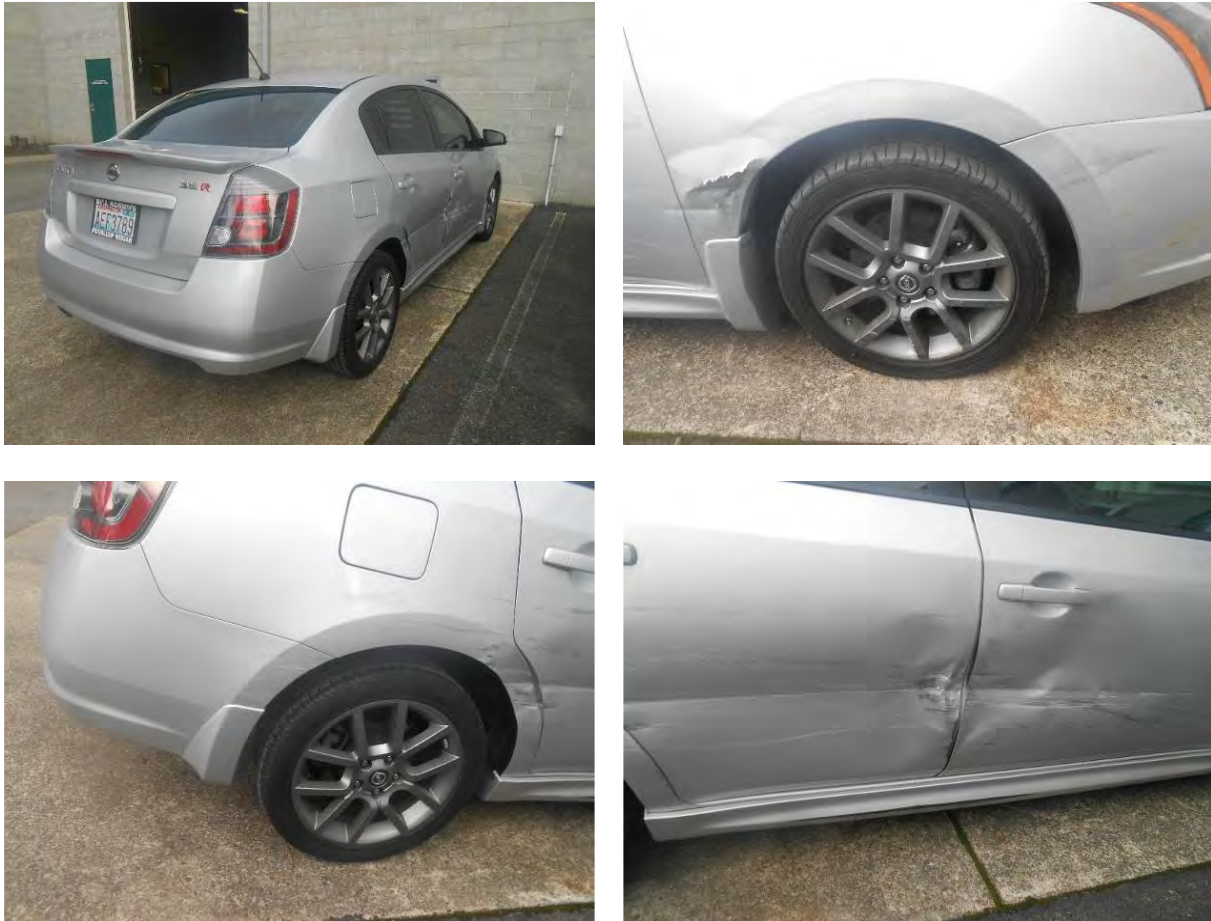
**Figure 1: Reproductions of the subject 2011 Nissan Sentra**

The Estimate of Record for the subject Nissan Sentra reported damage primarily to the front bumper cover, right fender, right front wheel, right rear wheel, right rocker molding, right front door shell, right rear door shell, right quarter panel, and rear bumper cover due to the subject incident. Specifically, the rear bumper cover was repaired and not replaced. The reviewed photographs of the subject Nissan depicted a horizontal line a crush, primarily to the two passenger side doors (Figure 1). The photographs depicted scuffs/scratches to the front and rear bumper covers with some crush damage to the passenger side fender and quarter panel. Additionally, there were horizontal scratches along the entire passenger side of the subject Nissan. Mr. Swanson testified the tire indicator light came on, the passenger door was unable to open, and the Nissan started making a grinding sound from the right side.

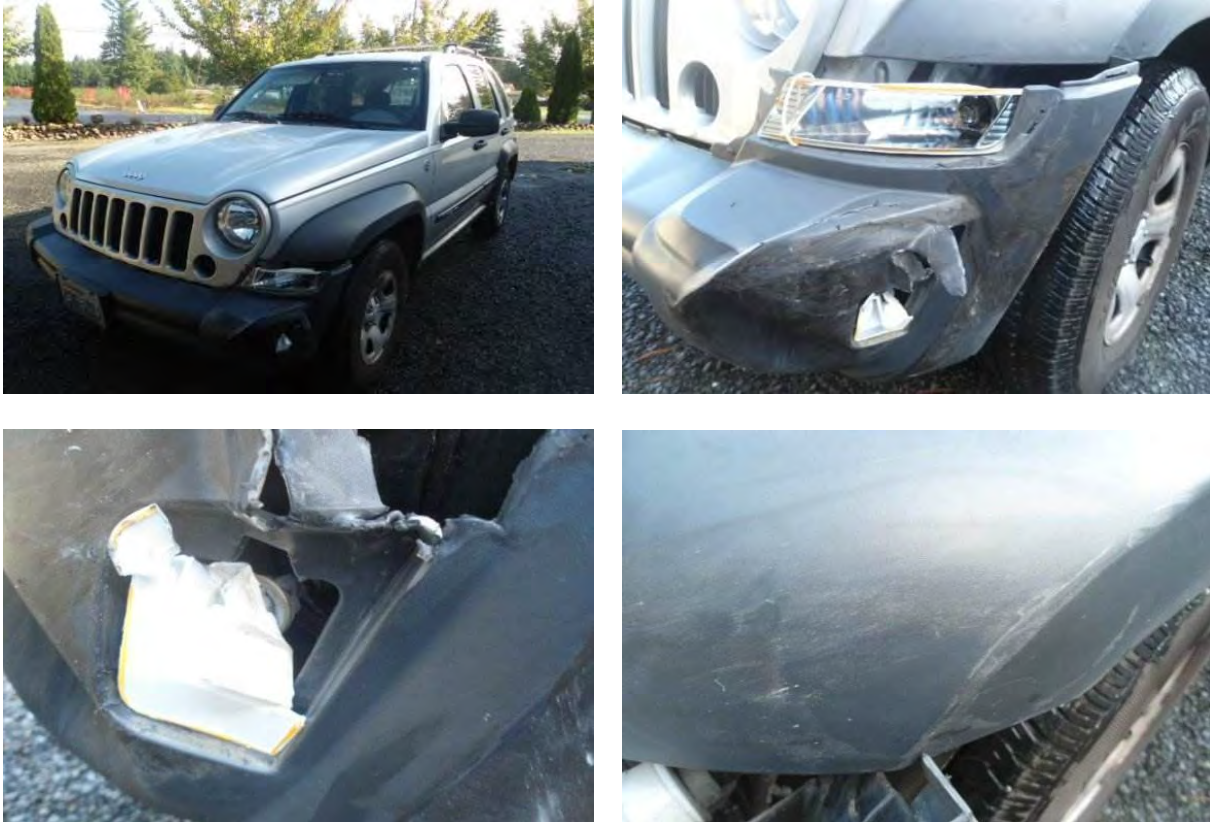
**Figure 2: Reproductions of the incident 2007 Jeep Liberty**

The Estimate of Record for the incident Jeep Liberty reported damage primarily to front bumper cover, wire harness, left park and side lamp, left side marker lamp, left park lamp bulb, left fender liner, left wheel flare, and left fender liner retainer due to the subject incident. Specifically, the rear bumper cover was repaired and not replaced. The reviewed photographs of the subject Jeep depicted the driver's side front corner had minor crush to plastic components (Figure 1). No structural or significant metal components were indicated as damage in the repair records or in the reviewed photographs.

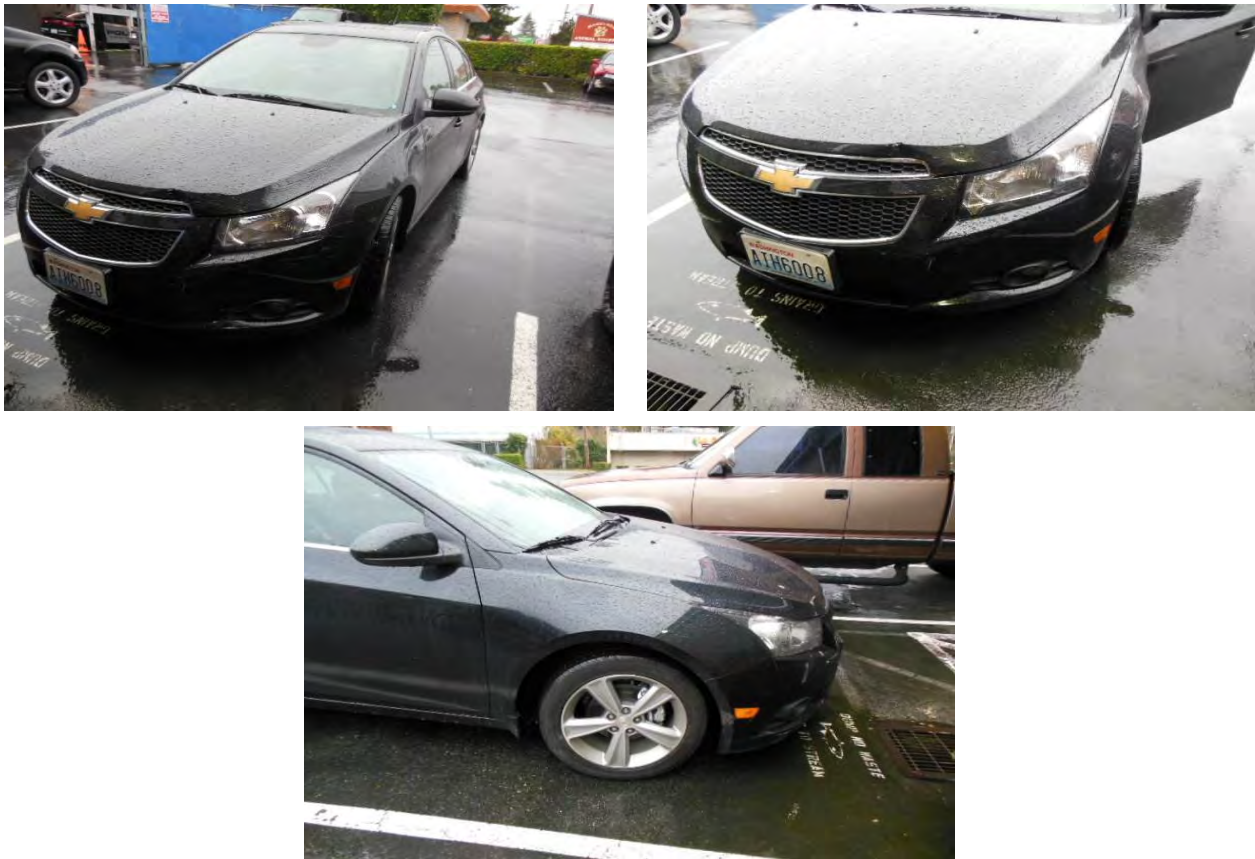
**Figure 1: Reproductions of photographs of the subject 2012 Chevrolet Cruze**

The repair estimate for the subject Chevrolet Cruze reported damage to the front bumper cover, front emblem, upper/center grille, left headlamp assembly, fog lamps, and inner edge of the hood, which is consistent with the reviewed photographs (Figure 1). The photographs depicted minor residual crush to the left front of the hood, as well as the lower left of the bumper near the fog lamp. Both Mr. Scott and Ms. Rex noted damage to the front driver's side of the Chevrolet Cruze.

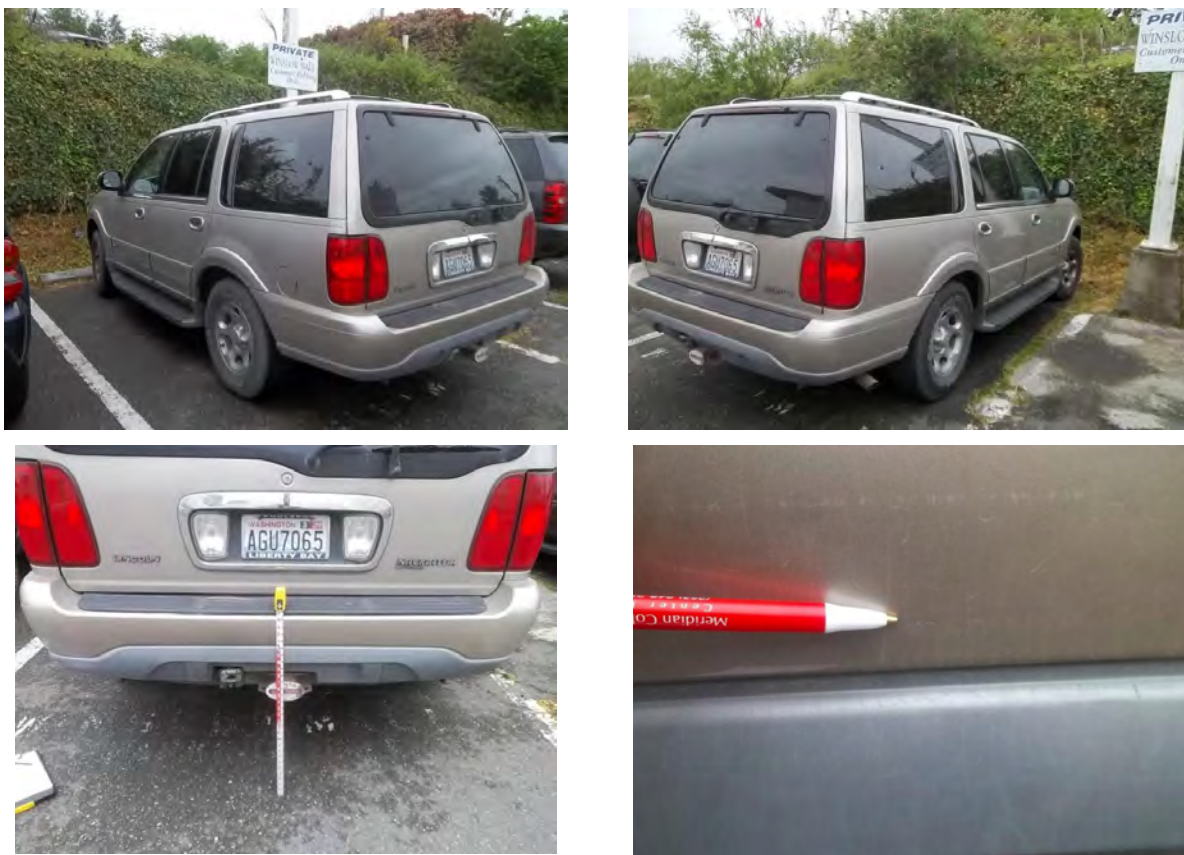
**Figure 1: Reproductions of photographs of the subject 2001 Lincoln Navigator**

The repair estimate for the subject 2001 Lincoln Navigator reported damage to the rear bumper cover, which is consistent with the reviewed photographs (Figure 1). In addition, the repair documents noted prior collision damage to the driver's side fender. The photographs depicted no residual crush to the rear of the Lincoln Navigator. Ms. Pomeroy's testimony indicated she observed no damage to the bumper.

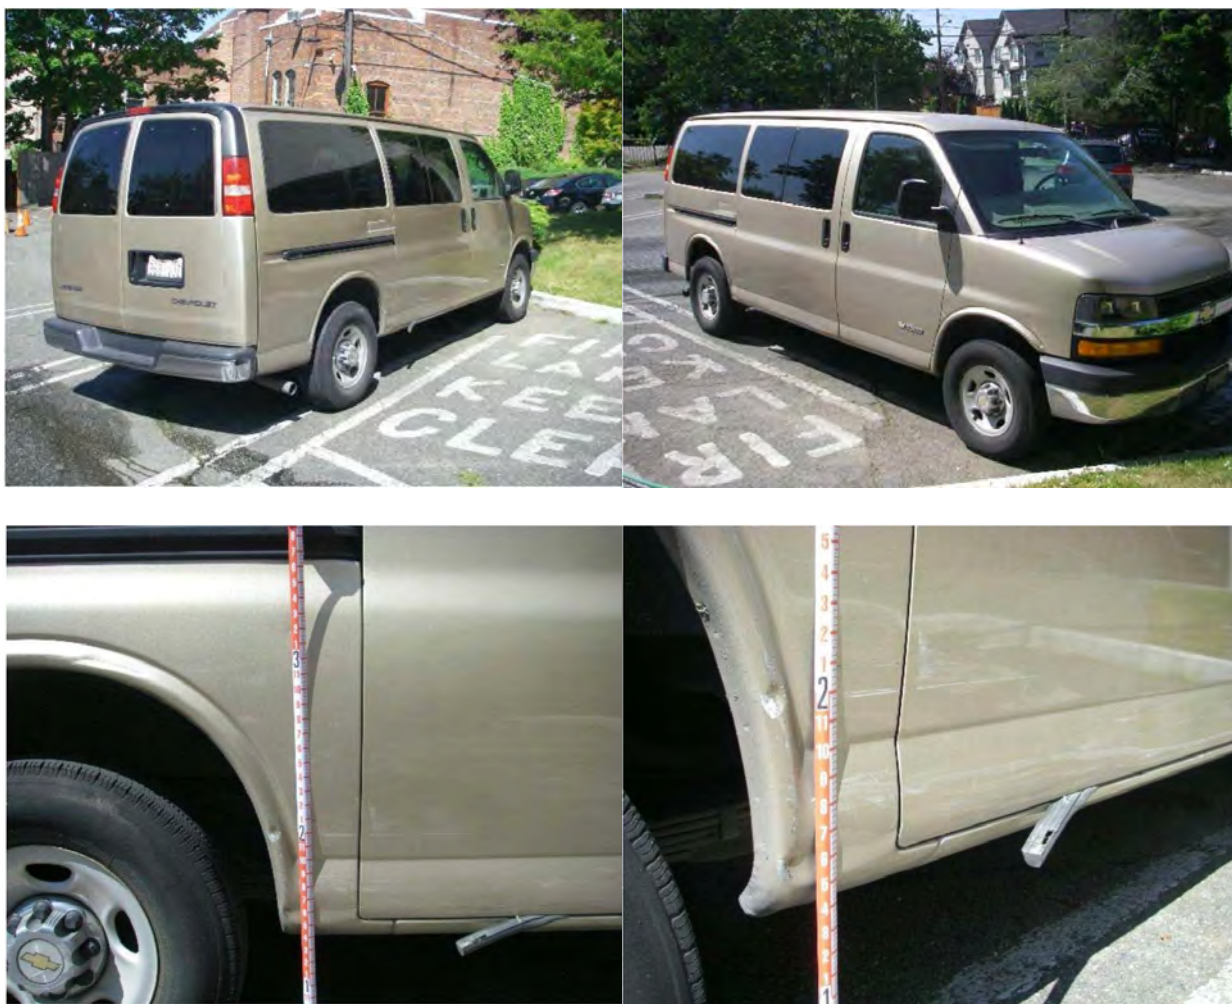
**Figure 2: Reproductions of photographs of the incident 2005 Chevrolet Express 3500**

Estimate of Record. No structural or significant metal components were indicated as damage in the repair records or in the reviewed photographs.

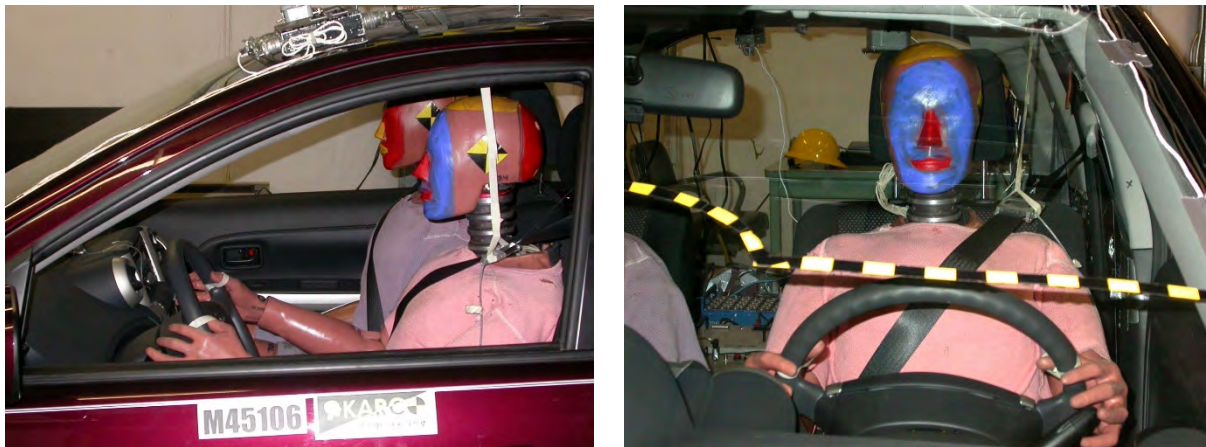
**Figure 3: NHTSA 50<sup>th</sup> Percentile Male ATD in 2004 Scion xA**

supported and constrained by the seatback structure of the subject Scion. Had Ms. Gaines's body experienced enough energy to cause motion, the only general exposure for biomechanical failure of a properly seated occupant in such a minor impact is due to the relative motion of the head and neck with respect to the torso, causing a "whiplash" biomechanical failure to the neck. The primary mechanism for this type of biomechanical failure occurs when the head hyperextends over the headrest of the seat. The National Highway Traffic Safety Administration (NHTSA) conducts impact safety tests for continued performance and safety monitoring of the automotive industry. Testing for a 2004 Scion xA, production model years 2004-2007, showed the seated height of a 50<sup>th</sup> percentile male in the driver's seat was well protected and supported by the seatback components (Figure 3).<sup>28</sup>

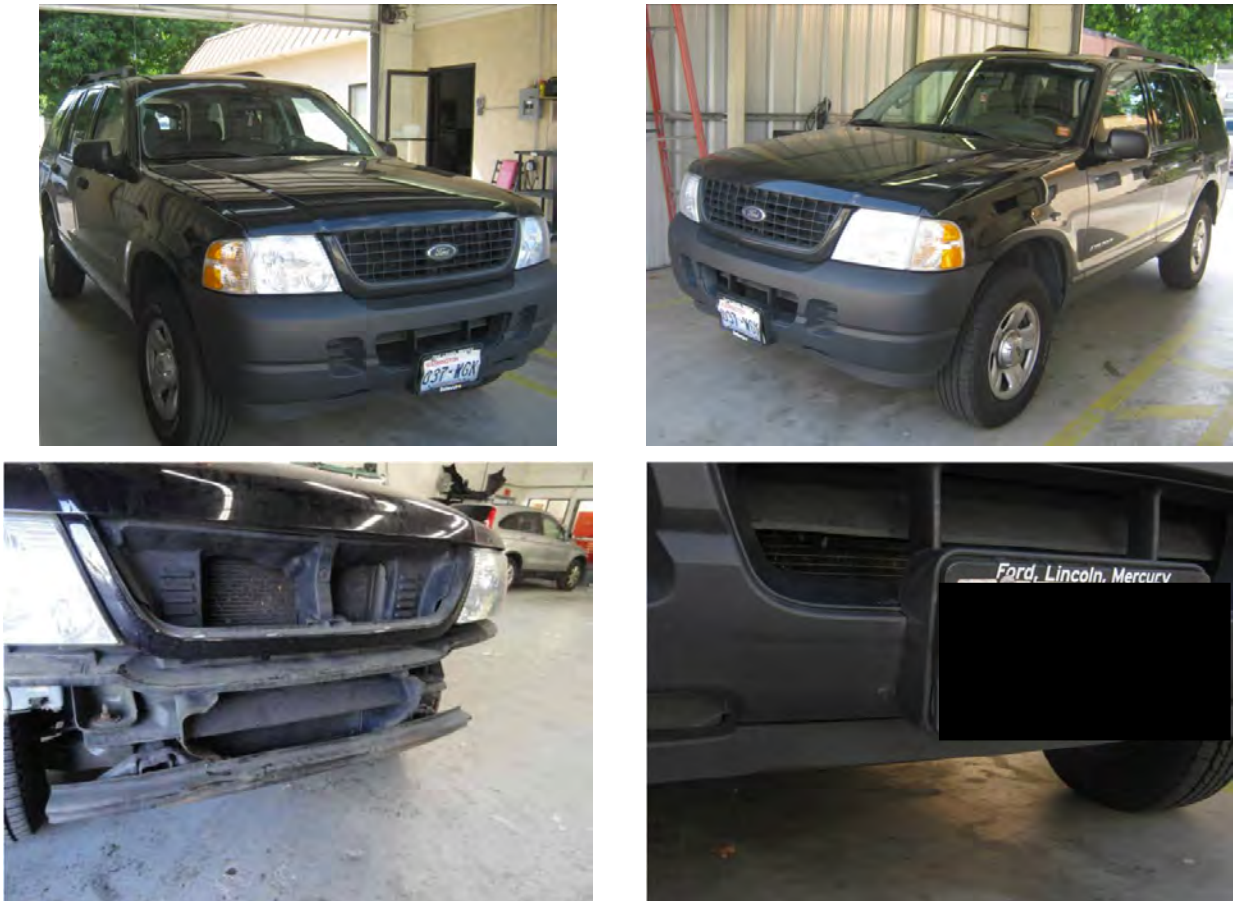
**Figure 1: Reproduction of the front of the subject 2005 Ford Explorer**

As previously stated, it is claimed that the 2005 Ford Explorer was struck from the rear by the incident 2009 GMC Sierra resulting in the Explorer being pushed into the rear of the 1996 Chevrolet Corsica. For the front of the subject Explorer, the repair documentation reported damage to the front bumper cover, license plate, lower grill, absorber, and impact bar, consistent with the photographs (Figure 1). Further, the documents indicated the front required a frame measurement. The photographs of the front of the Explorer depicted a bent license plate and partial deformation to the right side of the reinforcement bar.

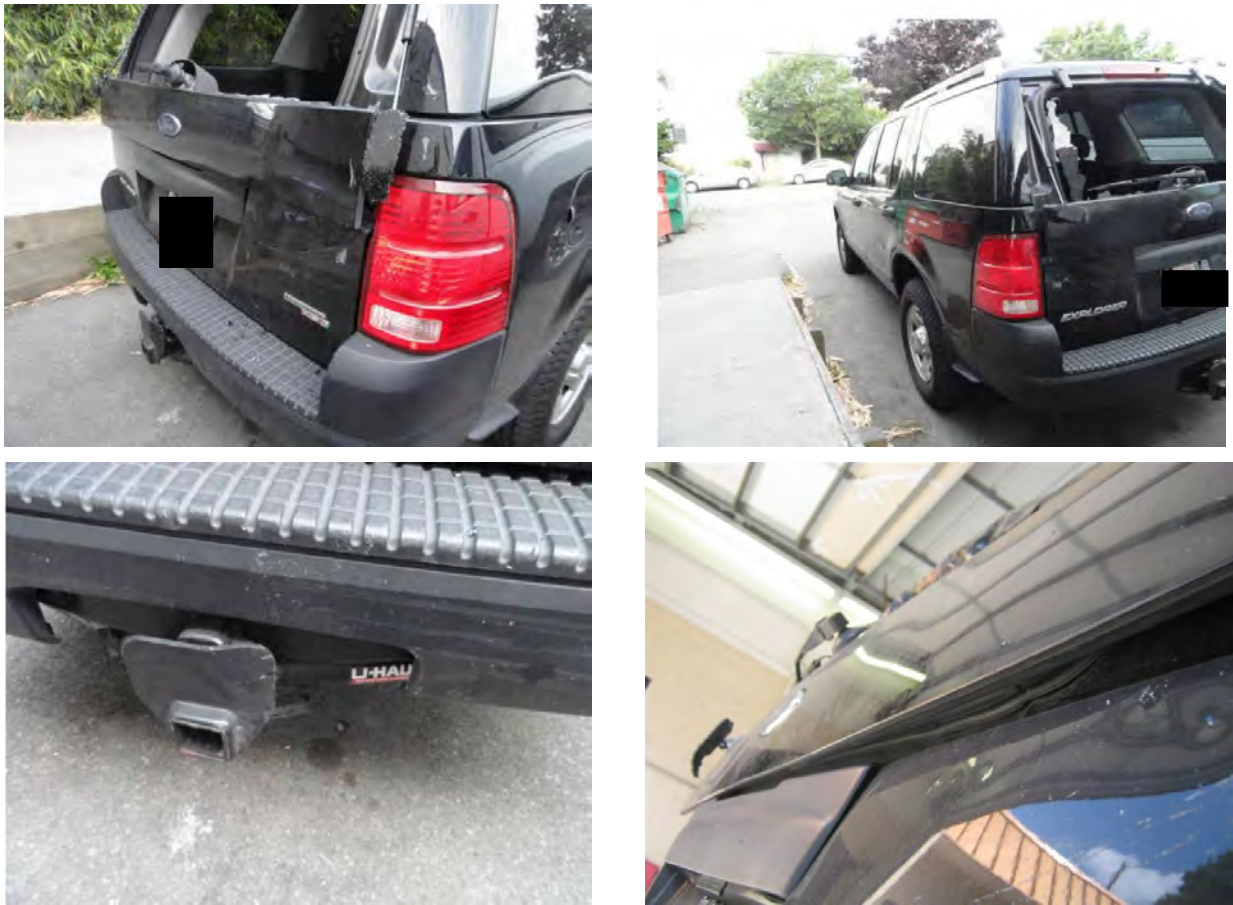
**Figure 2: Reproduction of the rear of the subject 2005 Ford Explorer**

Regarding the rear damage to the subject Explorer, the estimate of record reported damage to the tailgate plate, tailgate glass, rear bumper and step pad, and trailer hitch, consistent with the photographs (Figure 2). Further, the documents indicated the rear required a frame measurement. The photographs of the rear depicted crush to the lower tailgate, shattered tailgate glass, bent receiver hitch apron, and scrapes to the bumper cover and tailgate.

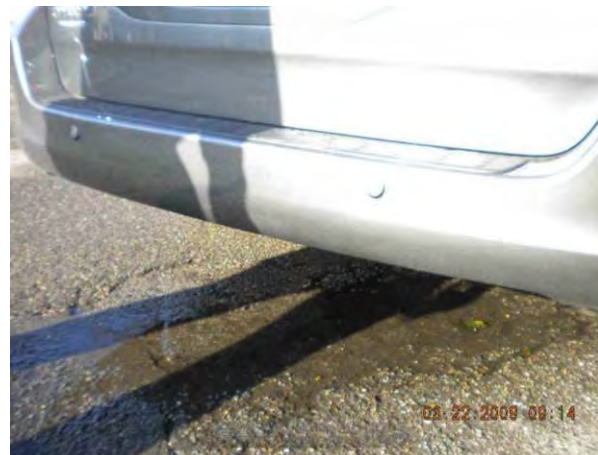
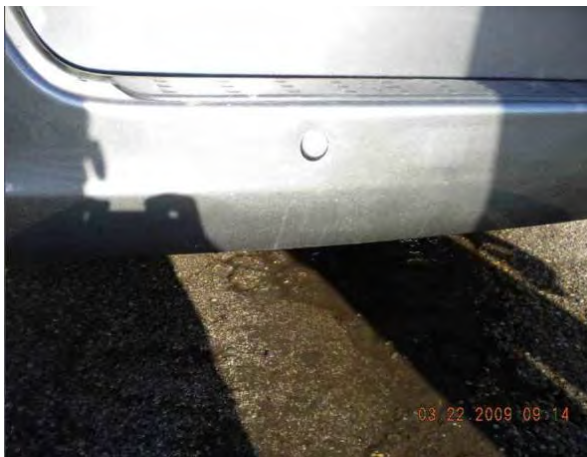
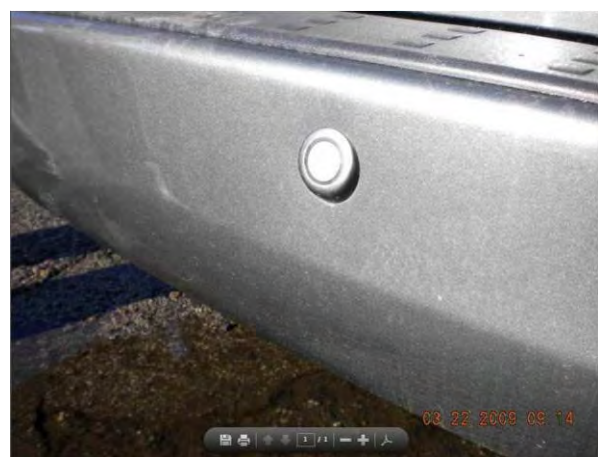
**Figure 1: Reproductions of photographs of the subject 2007 Honda Odyssey**

The damage to the subject 2007 Honda Odyssey defined by the photographic reproductions, and confirmed by the repair estimate, was used to perform a damage threshold speed change analysis.<sup>13,14</sup> The Insurance Institute for Highway Safety (IIHS) performs low-speed tests on vehicles to assess the performance of the vehicles' bumpers and the damage incurred. The IIHS tested a 2008 Honda Odyssey<sup>15</sup> in a 6.2 mile-per-hour rear full-overlap impact. During the IIHS rear impact the test Honda Odyssey sustained damage to the inner tailgate shell, rear body floor, tailgate shell, rear bumper, and rear bumper cover. Specifically, the test results noted "*in addition to bumper cover and reinforcement damage, the rear body panel was buckled around the sidemember ends*" and "*the rear bumper cover vertically loaded the tailgate, rolling the lower edge*". The primary damage to the subject Honda Odyssey was to the rear bumper cover and rear backup sensors. Thus, because the test Honda in the IIHS test sustained greater damage, the severity and energy transfer of the IIHS impact is greater compared to the severity of the subject incident and places the subject incident consistent with an impact less than 6.2 miles-per-hour for the subject Honda Odyssey. Accounting for the coefficient of restitution, the subject incident resulted in a Delta-V significantly below 8.0 miles-per-hour for the subject Honda Odyssey. Additionally, the above analysis is consistent with an energy crush analysis to the rear of a 2007 Honda Odyssey and IIHS low-speed crash test results for a Kia Sedona.<sup>16,17,18,19,20</sup>

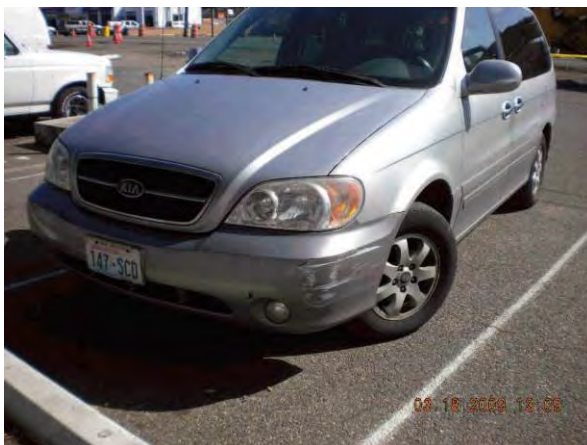
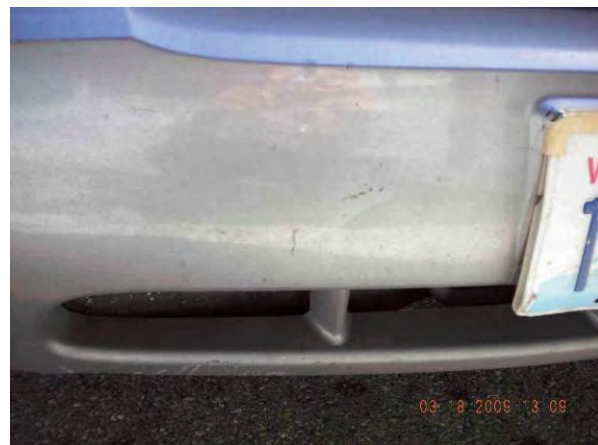
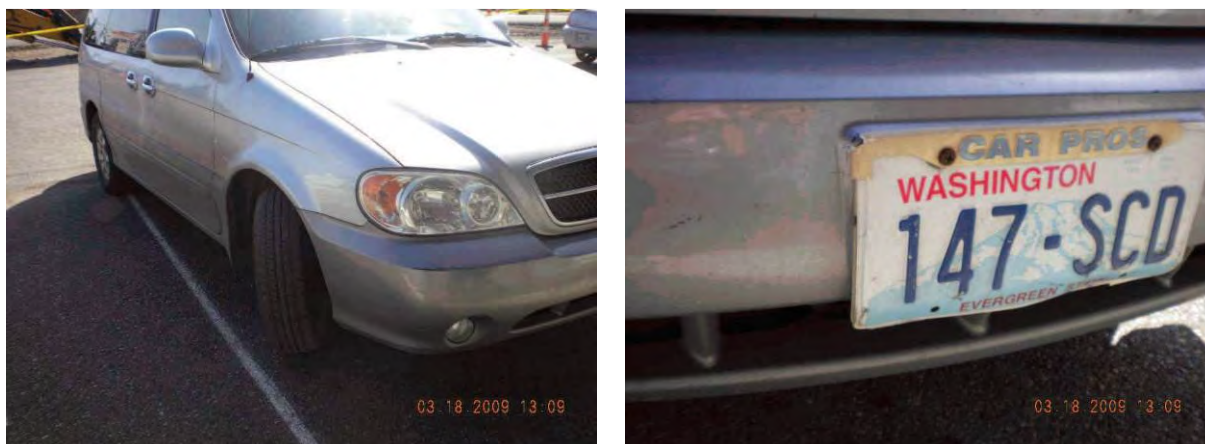
**Figure 2: Reproductions of photographs of the subject 2004 Kia Sedona**

The reviewed photographs of the incident Kia depicted a broken front license plate bracket along with scuffing to the front bumper cover (Figure 2). The front bumper cover remained in proper alignment with the fender, hood, headlights, and grille along with displaying no visible signs of crush to the front bumper components.

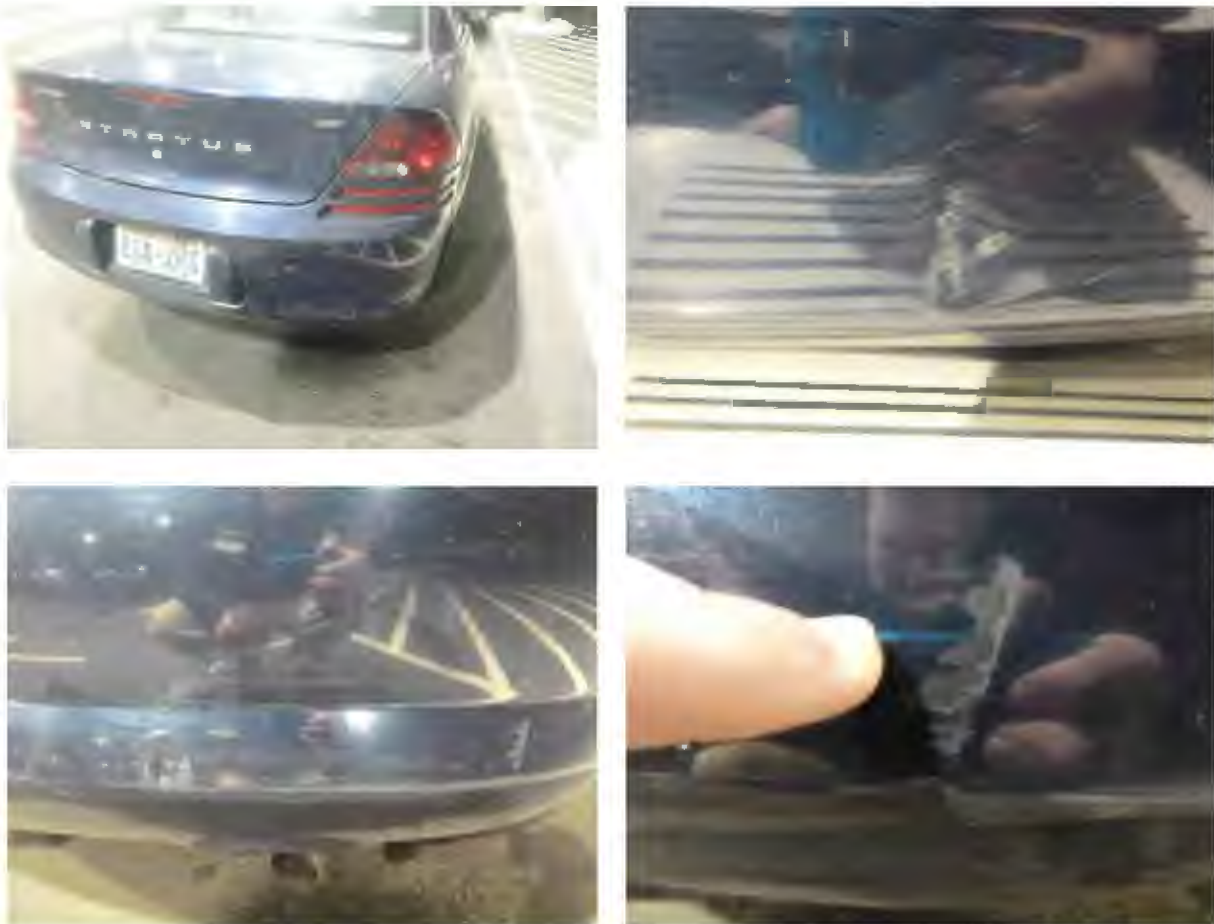
**Figure 1: Reproductions of photographs of the subject 2005 Dodge Stratus**

vehicle (Figure 1). Overall, the photographs depicted no misalignment of the rear bumper cover with the quarter panels, tail lights, or trunk lid. The documents indicated the subject Dodge was not repaired and the damage was very minor.

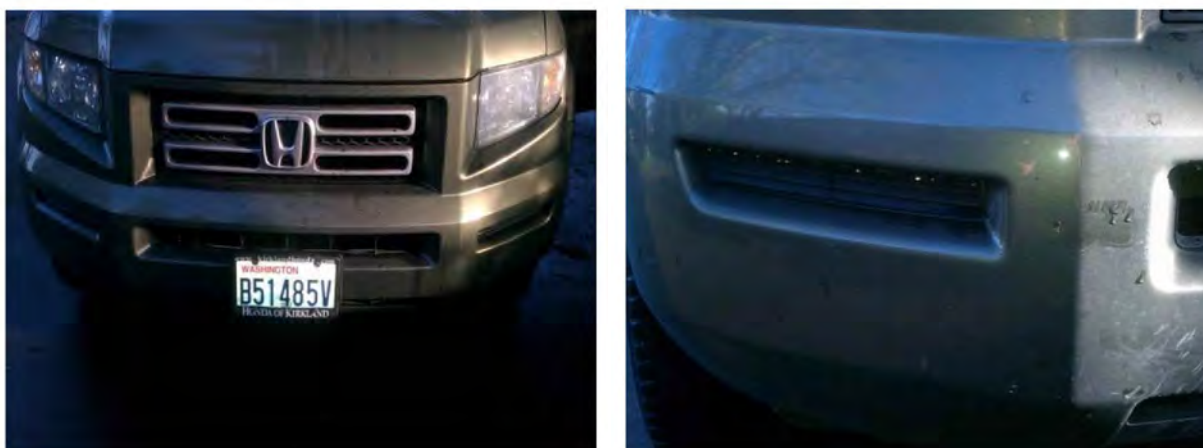
**Figure 2: Reproductions of photographs of the incident 2008 Honda Ridgeline**

The reviewed photographs of the incident Honda depicted scratches and scuffs to the front bumper cover skewed toward the passenger side (Figure 2). Overall, the front bumper cover remained in proper alignment with the grille, headlights, and hood.

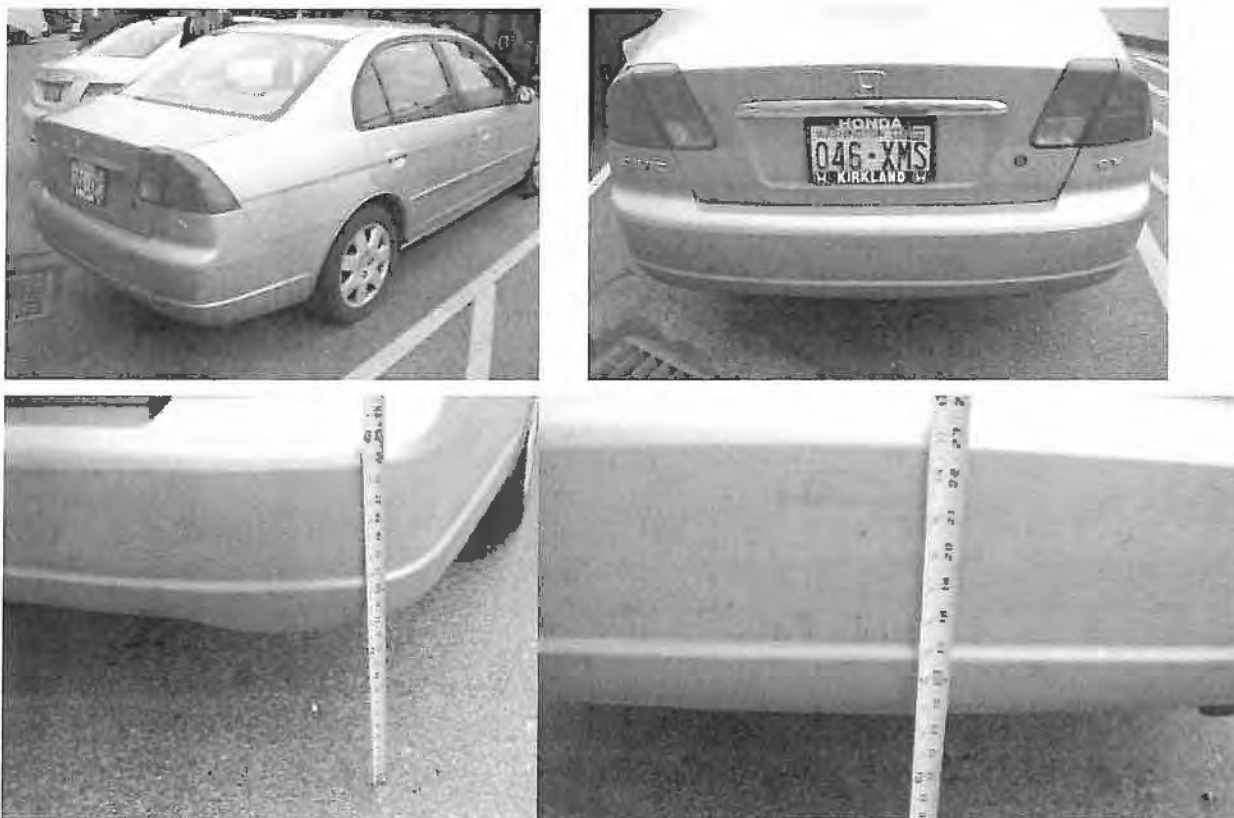
**Figure 1: Reproductions of photographs of the subject 2001 Honda Civic**

The repair estimate for the subject 2001 Honda Civic reported repairs, not replacement, of the rear bumper cover, which is consistent with the reviewed photographs (Figure 1). The photographs depicted scuffs and paint chips to the rear bumper, predominately on the center and right side. There was no residual crush or malalignment of the rear bumper cover with respect to the tail lights, trunk lid, or quarter panels. There was no indication of any structural component damage. Ms. Dupart testified that she *"noticed some damage, but it was minimal"*.

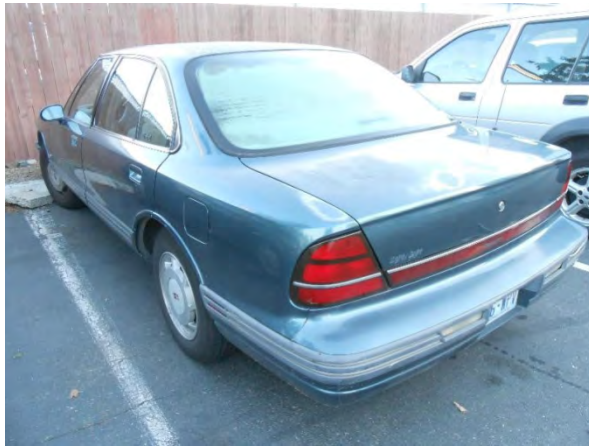
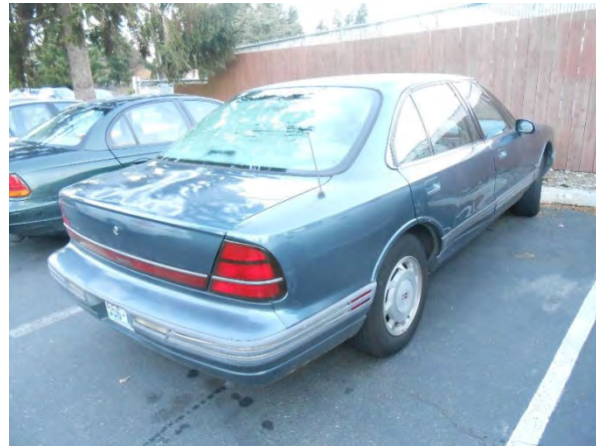
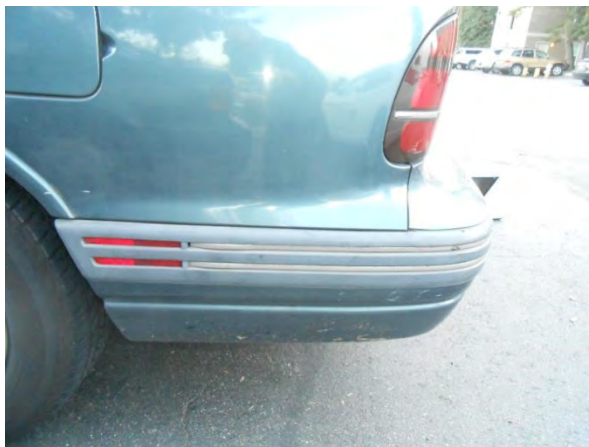
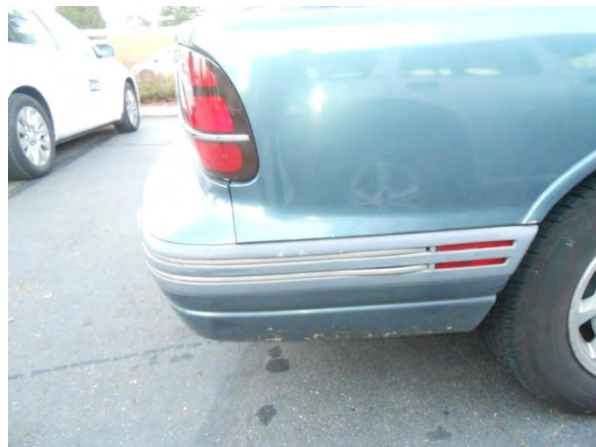
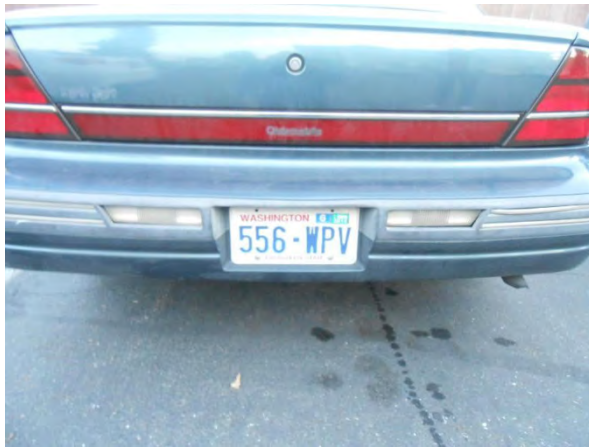
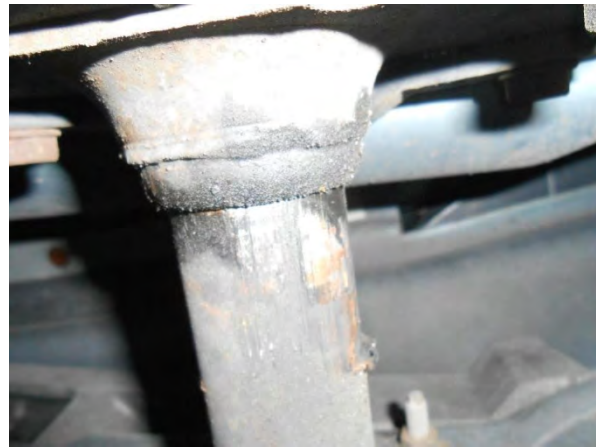
**Figure 1: Reproductions of photographs of the subject 1994 Oldsmobile Eighty Eight**

The Estimate of Repair for the subject 1994 Oldsmobile Eighty Eight reported damage to the left tail lamp assembly. The photographs for the subject 1994 Oldsmobile Eighty Eight showed no residual crush to the rear of the vehicle, however, there was evidence that one of the rear bumper isolators had stroked. There were some scratches to the left corner of the rear bumper below the trim, and a small crack to the lower corner of the left tail light. The trim around the rear bumper cover was sticking out in various places. The rear bumper cover was in proper alignment with the quarter panels, tail lights, and trunk lid. Mr. Mekhael's testimony indicated that the damages to the subject Oldsmobile were minimal, stating, "*wasn't that damages that much*".
